NASA Technical Memorandum 80102

**Comparative Analysis of PA-31-350
Chieftain (N44LV) Accident
and NASA Crash Test Data**

Robert J. Hayduk
Langley Research Center
Hampton, Virginia

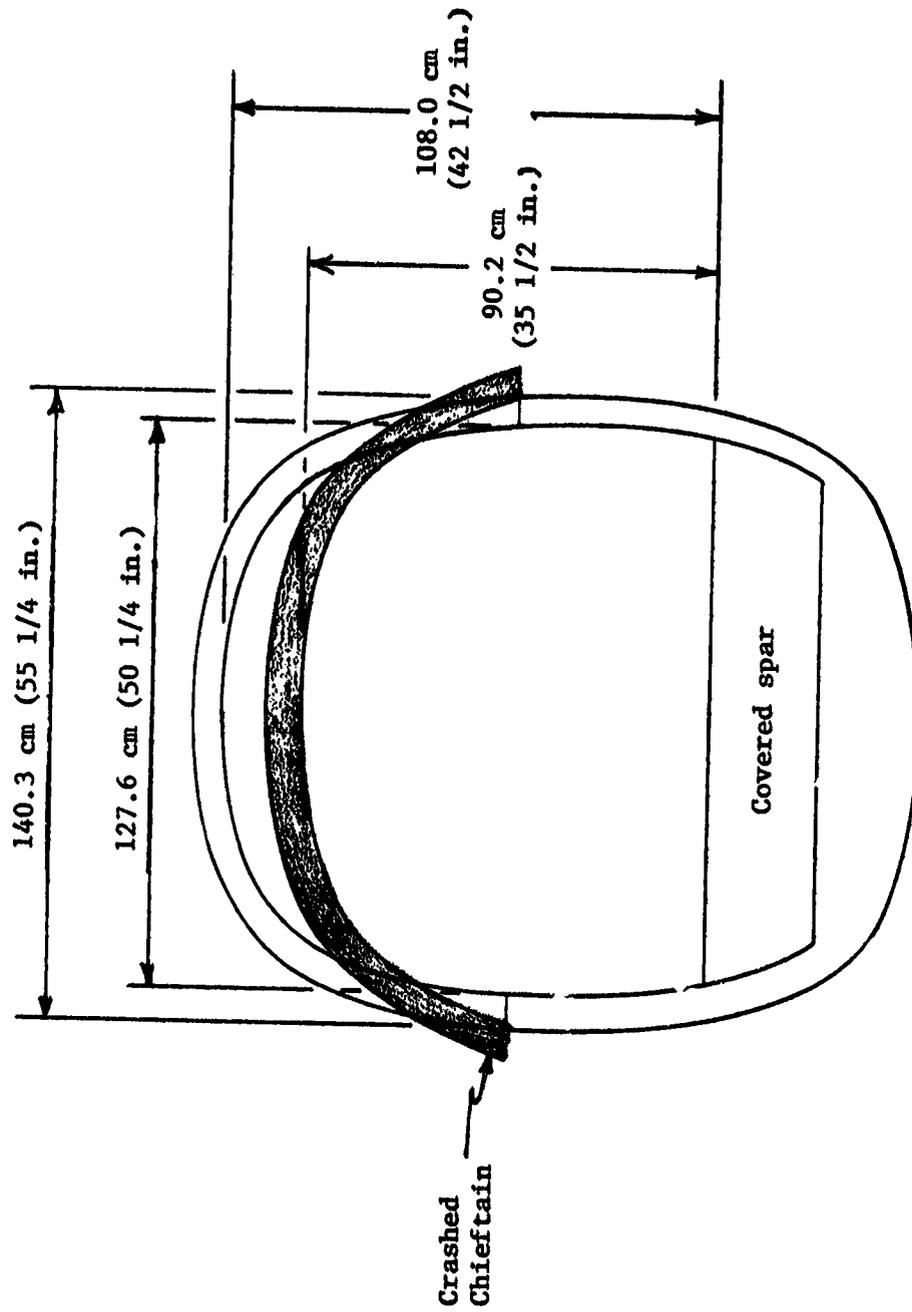
The interior measurements of the cabin taken at the main spar (fig. 4) indicate a 13-cm (5-in.) lateral expansion and an 18-cm (7-in.) drop in the ceiling. The actual changes of dimensions during the impact were probably substantially greater than the measured final dimensions. During the nose-down impact of the NASA test 7 specimen, the entire cockpit roof folded and caved in, only to unfold instants later.

Figure 4.- Fuselage cross-section distortion above covered main spar.

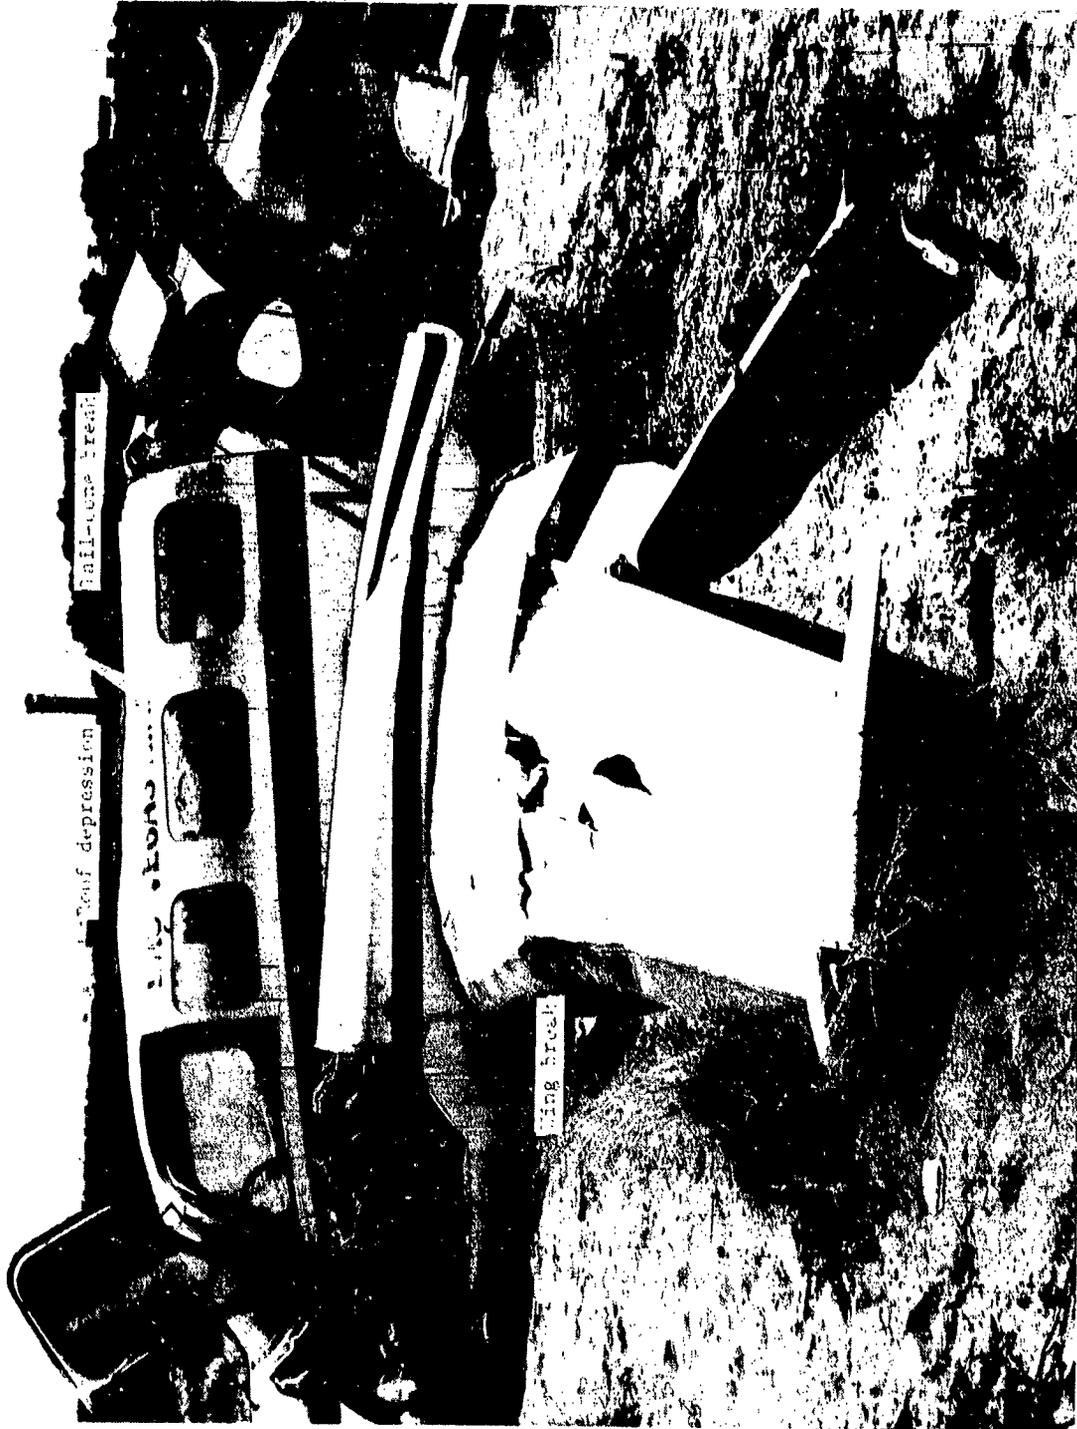
(a) Chieftain.

A left-side view of the Chieftain is shown in figure 7(a). This view shows the tail-cone breakdown, roof depression, and broken wing tip. The NASA test 10 specimen of figure 7(b) is typical of tail-cone breakdown in the NASA tests.

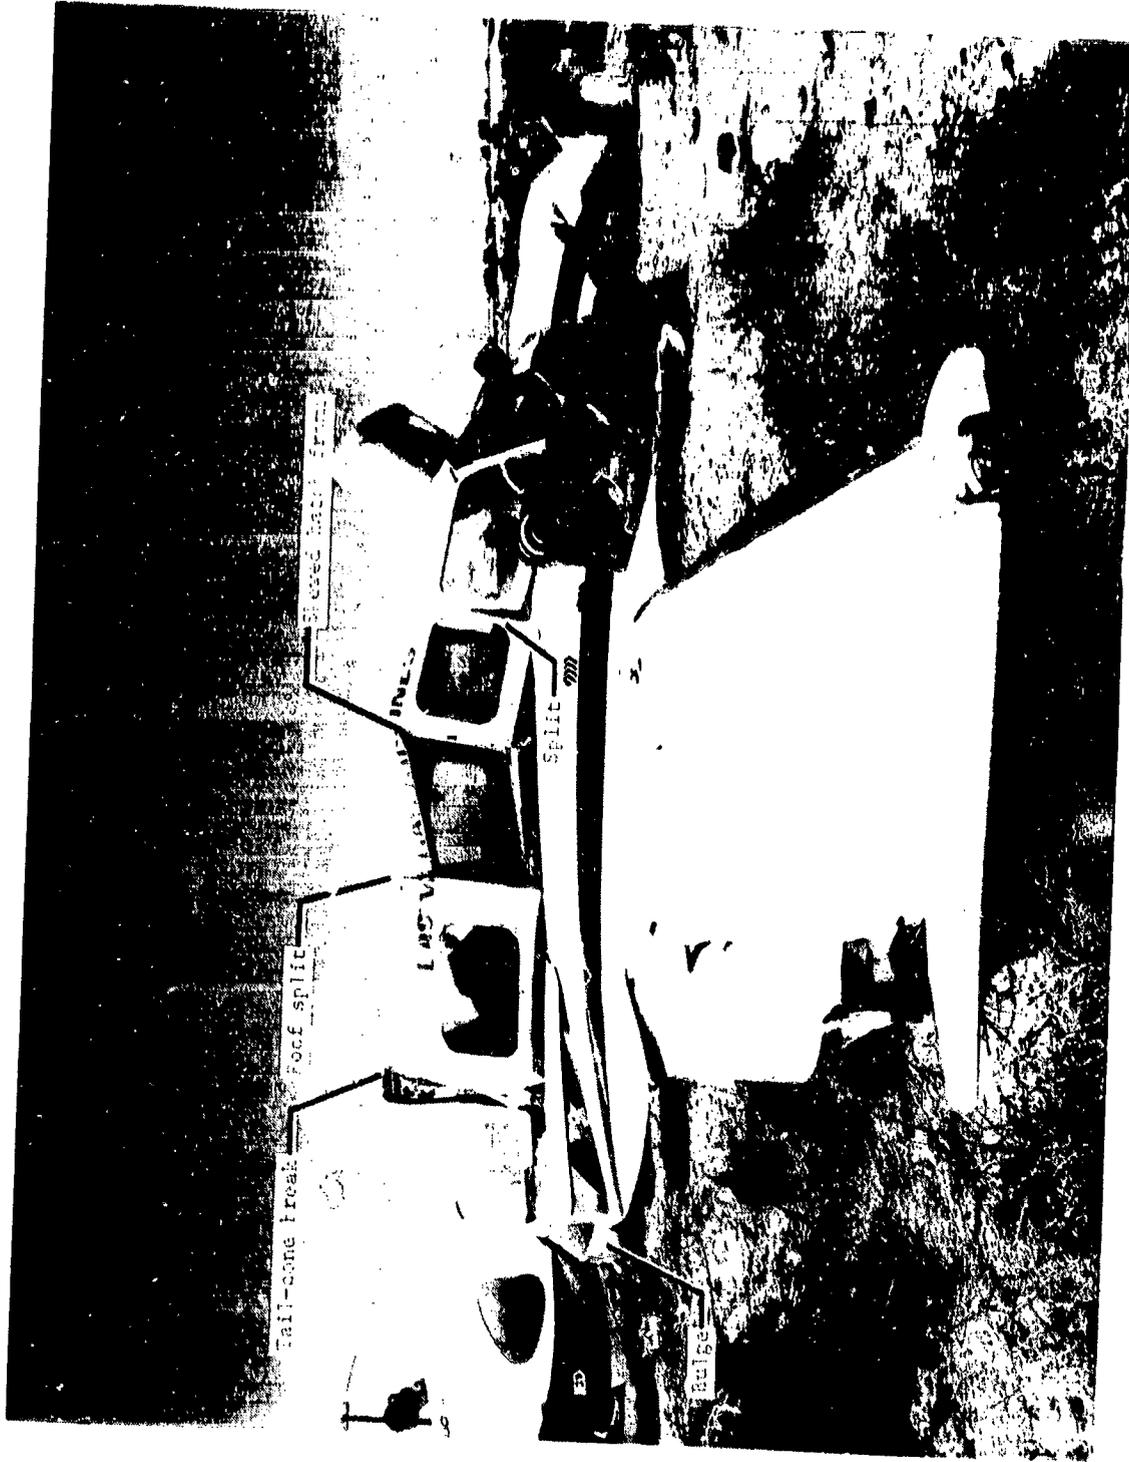
(a) Chieftain.

The right-side view of the Chieftain as shown in figure 8(a) shows the extensive damage to the right side of the fuselage with little damage to the wing. This side-fuselage damage is more severe than any of the NASA test airplanes have exhibited. Figures 8(b) and 8(c) show the NASA test 4 airplane, a nearly flat impact, and the test 2 airplane, a low-angle nose-down impact. These two specimens show some cabin roof depression and slight skewing of the escape hatch frame.

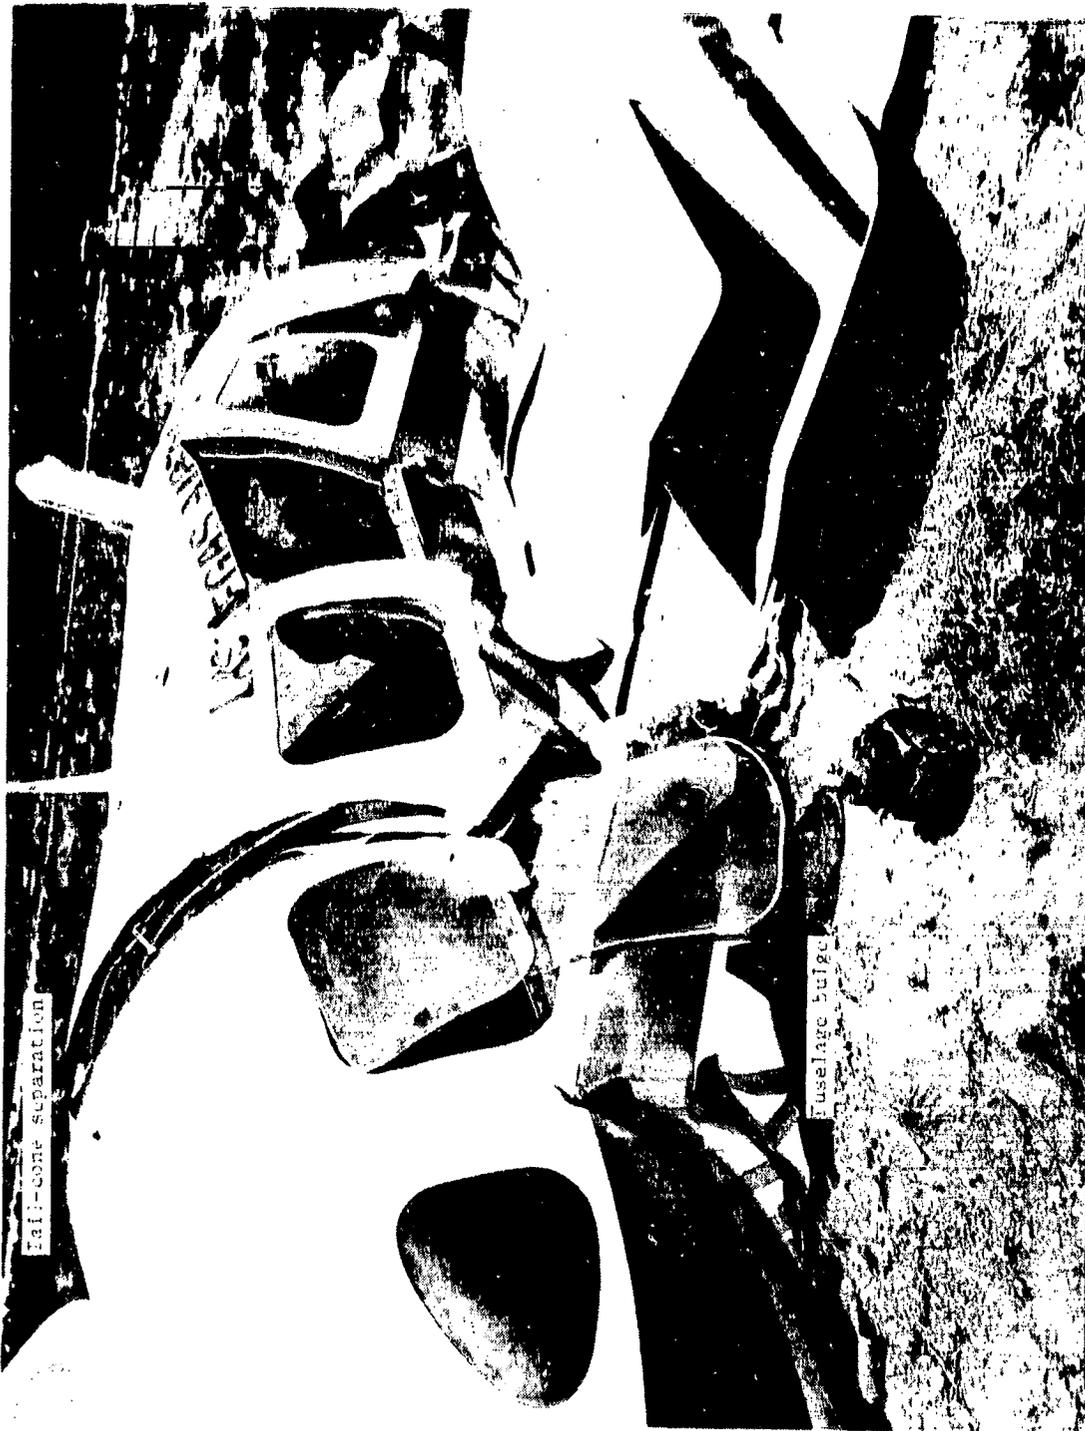
(a) Chieftain.

The tail-cone separation and bulge in the Chieftain's fuselage are shown in figure 9(a). Corresponding views showing tail-cone breakdowns in NASA tests 3 and 10 are shown in figures 9(b) and 9(c). The NASA test 4 specimen (fig. 9(d)) contacted the impact surface slightly pitched up. The damage is obviously in the same location as the Chieftain's bulge. Similarly, the NASA test 6 specimen, a tail-down impact (fig. 9(e)) shows similar damage. This specimen impacted along the tail undersurface, pitched up at a nominal 15°. The Chieftain's bulge indicated the initial contact point along the underbelly.

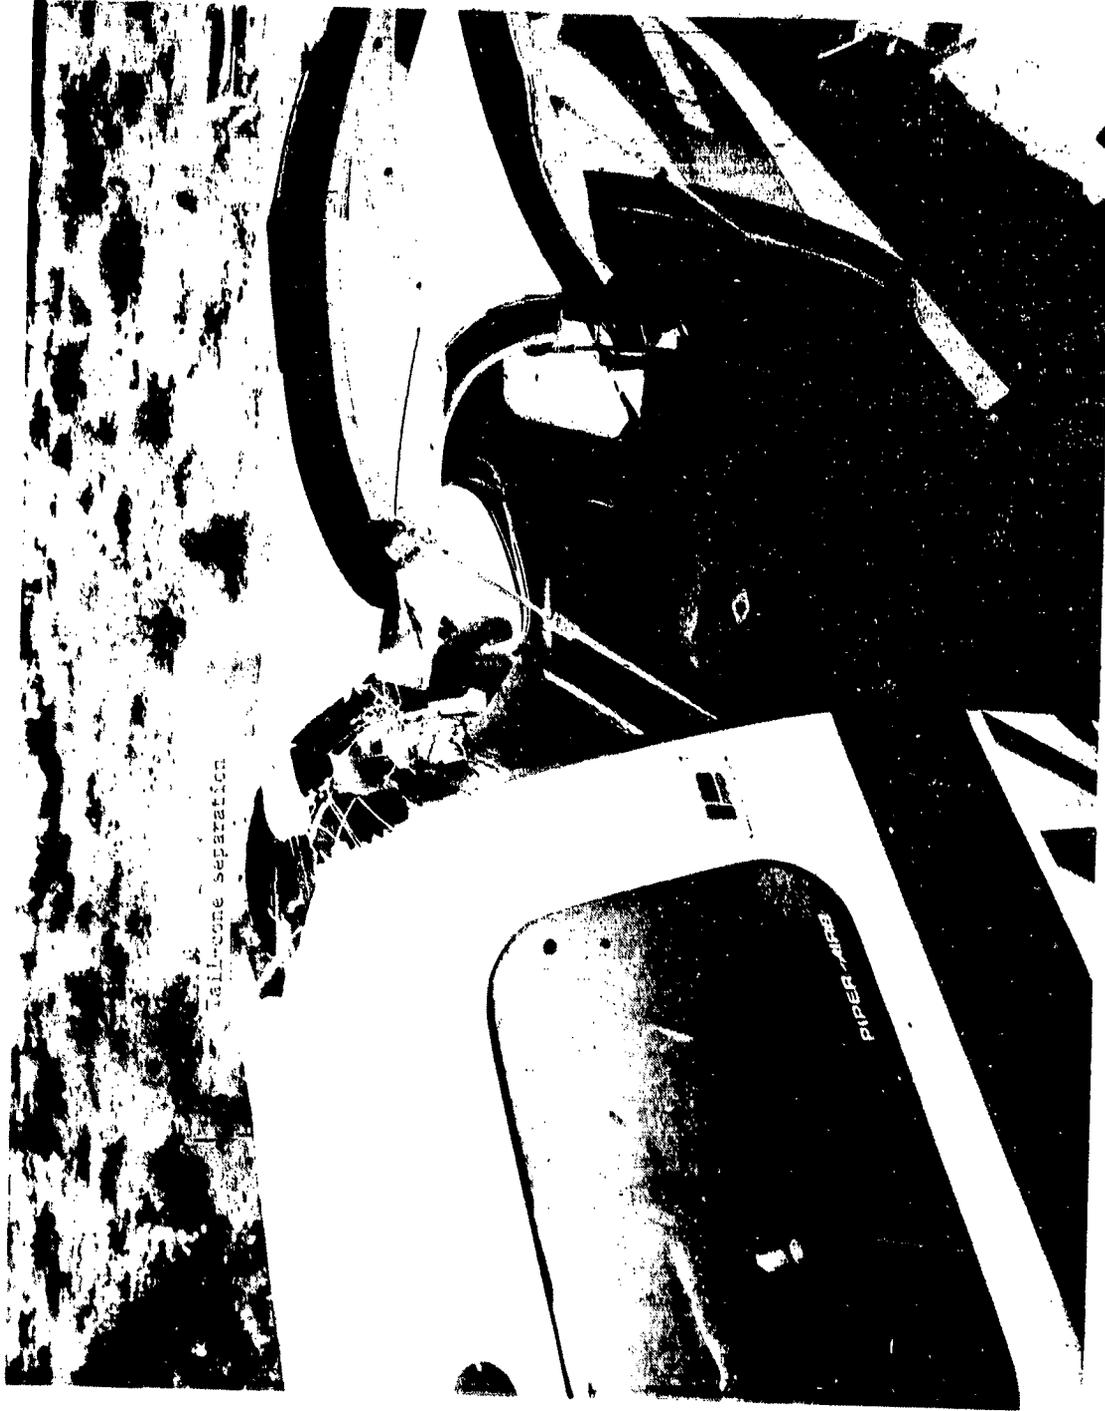
(a) Chieftain.

Figures 10(a), 10(b), and 10(c) show the upper separation of the tail cone of the Chieftain and comparable separations in specimens from NASA tests 10 and 3.

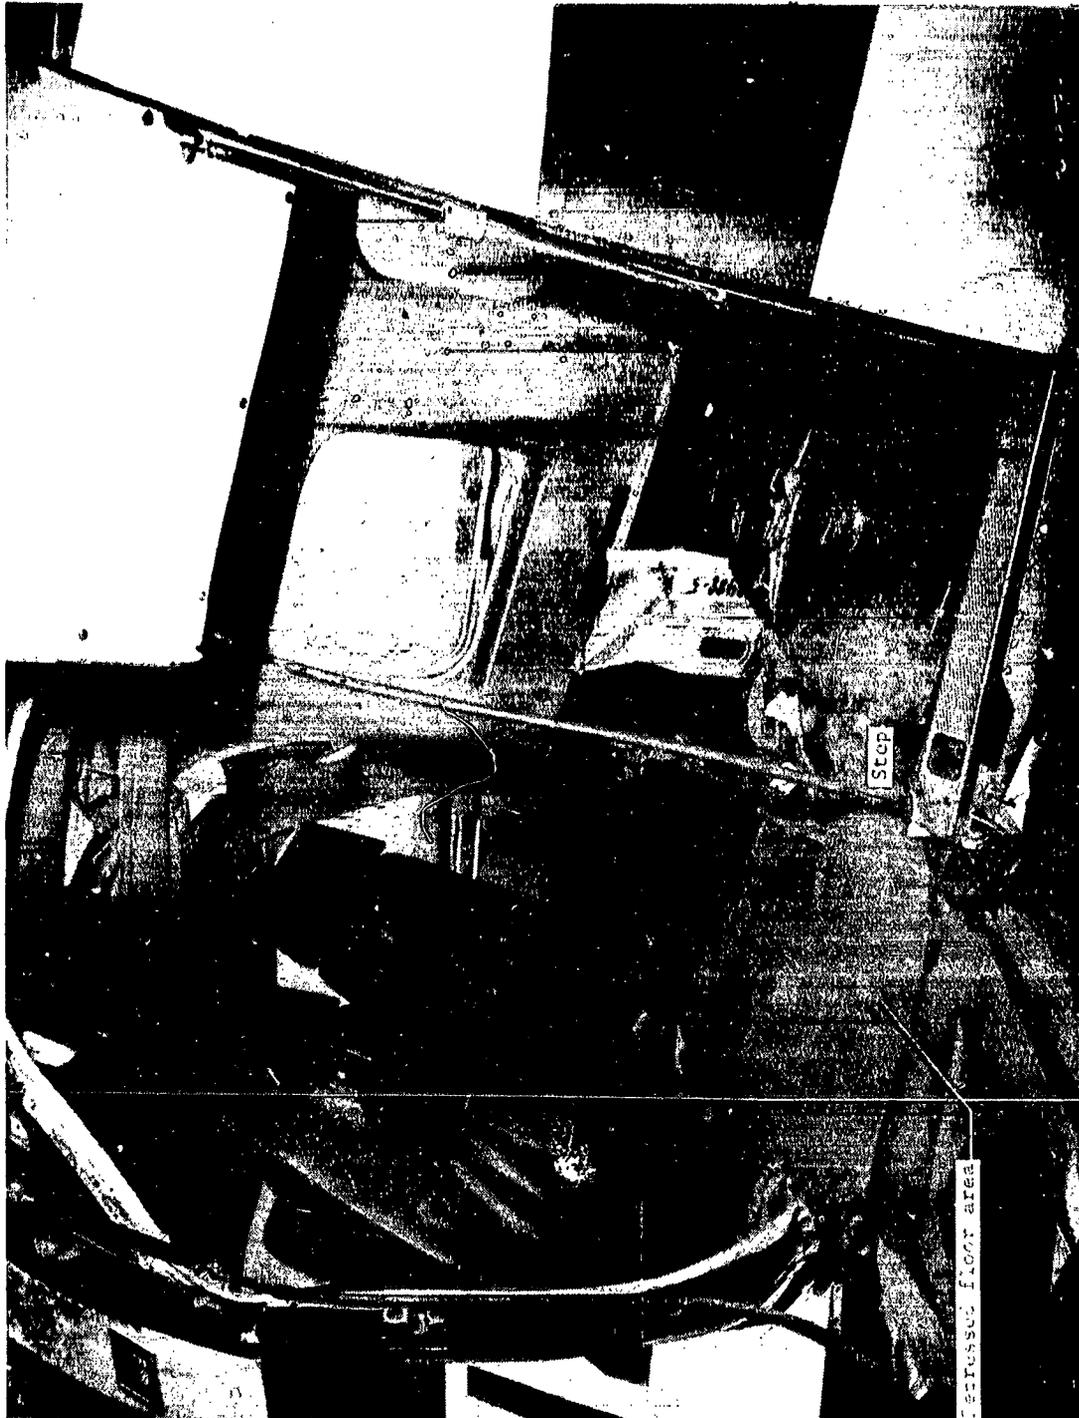
(a) Chieftain.

The rear cabin floor of the Chieftain (fig. 14(a)) shows a depressed floor area at the forward seat leg and passenger feet locations. The forward fuselage frame at the door was completely broken below the floor on the left side. The vertical step in the floor was deformed to about 45°. The view through the rear

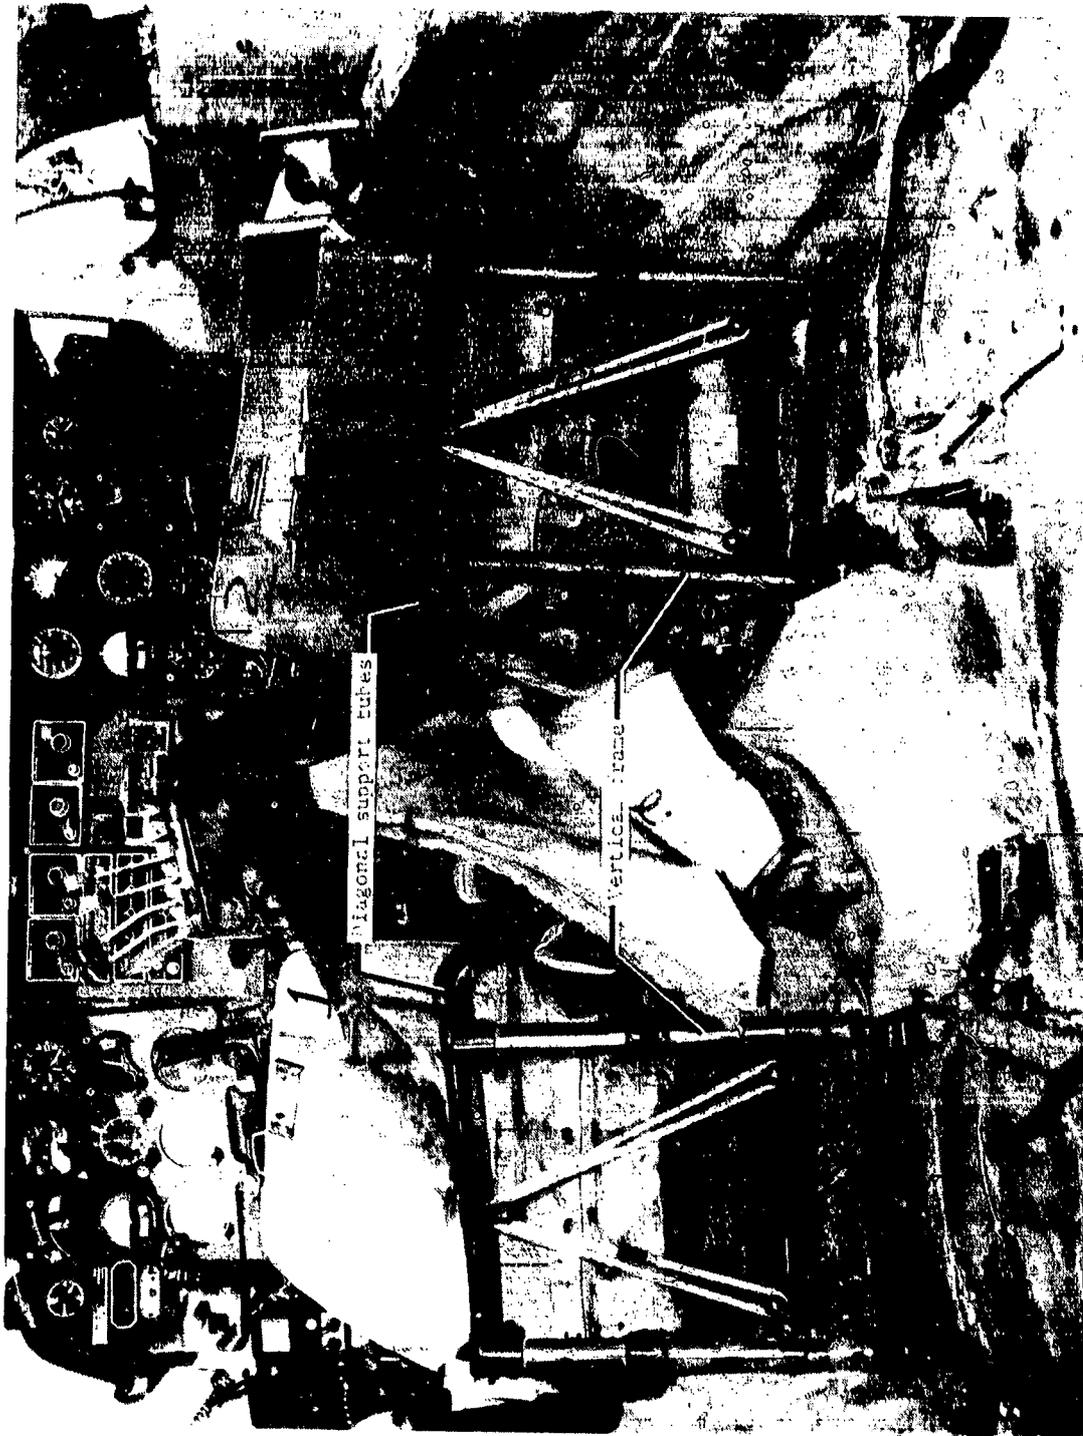
Both seats 1 (pilot) and 2 (copilot), as shown in figure 15(a), stayed firmly clamped to the floor rails. The rear vertical frames were bent forward approximately 30°. There was severe bending and fracturing of the side diagonal support tubes where they attach to the rear vertical frame. The seat cushions were folded downward in the center with the side frame members bent downward. The undertubing supporting the seat frames was also buckled. Similar damage has been seen in the NASA tests. Two pilot seats from NASA test 7 (fig. 15(b)) and NASA test 8 (fig. 15(c)), both of which were nose-down impacts, show bending and fracturing of the side diagonal support tubes.

(a) Pilot and copilot seats of Chieftain.

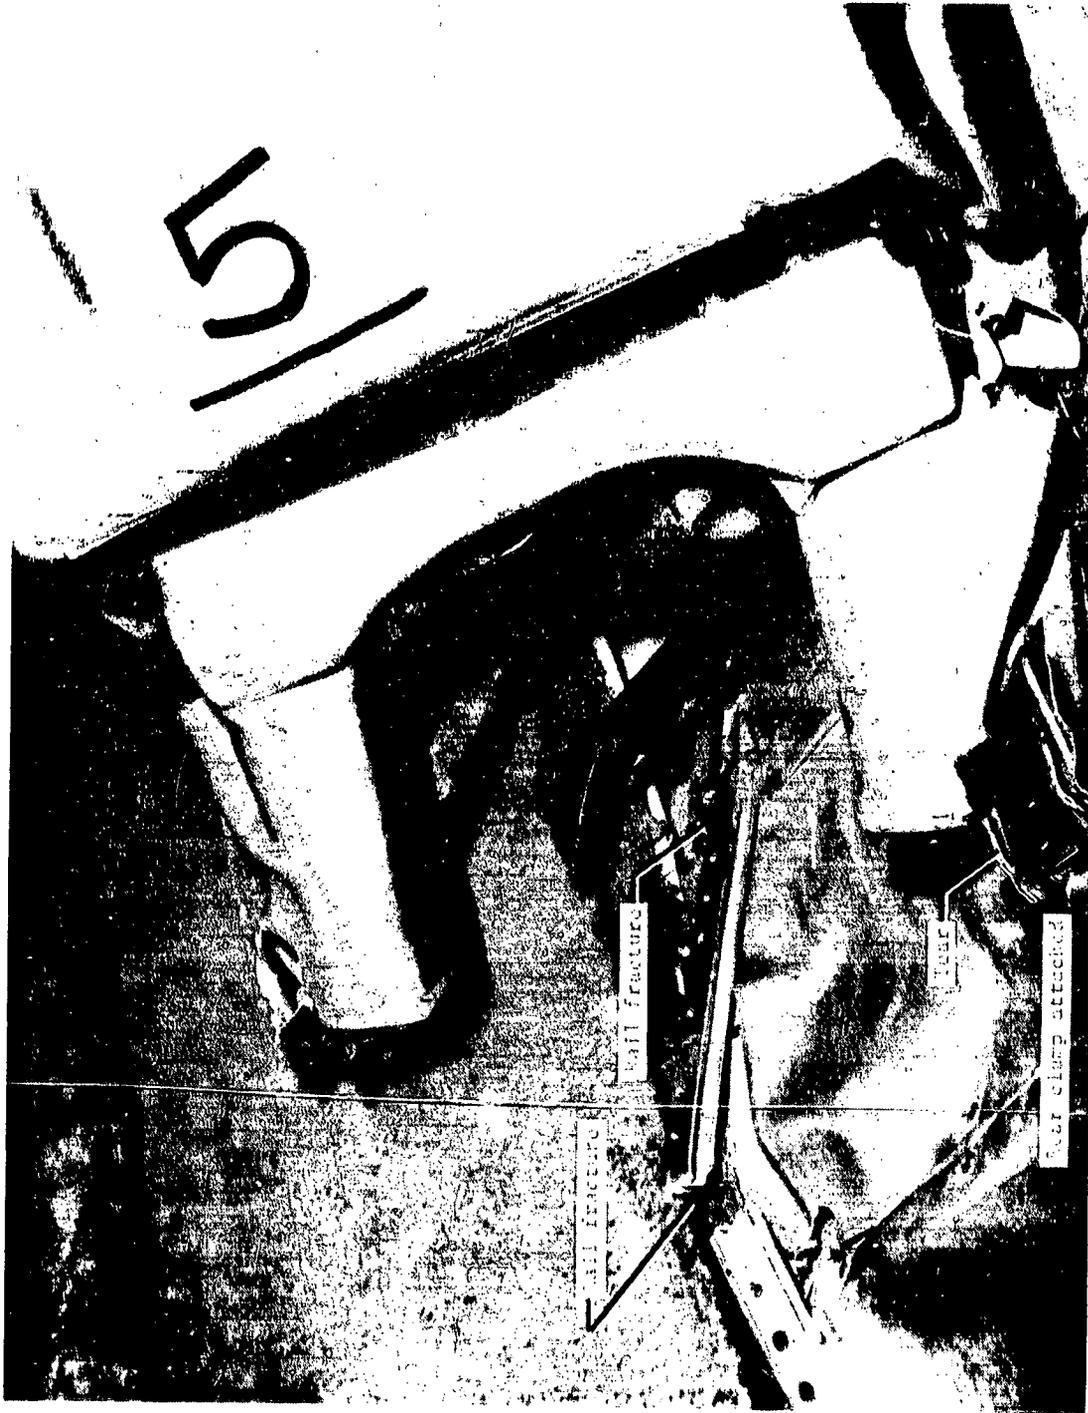
Figure 18.- Seat 5 of crashed Chieftain.

Figure 18 shows that seat 5 was severely distorted forward, downward, and to the right. Only the right rear clamp remained attached; however, the sheet-metal leg nearly tore free above the clamp. The left floor rail fractured in three places - at both the front and the rear leg attachment points and in between. The right rail was also fractured at the right front leg attachment point.

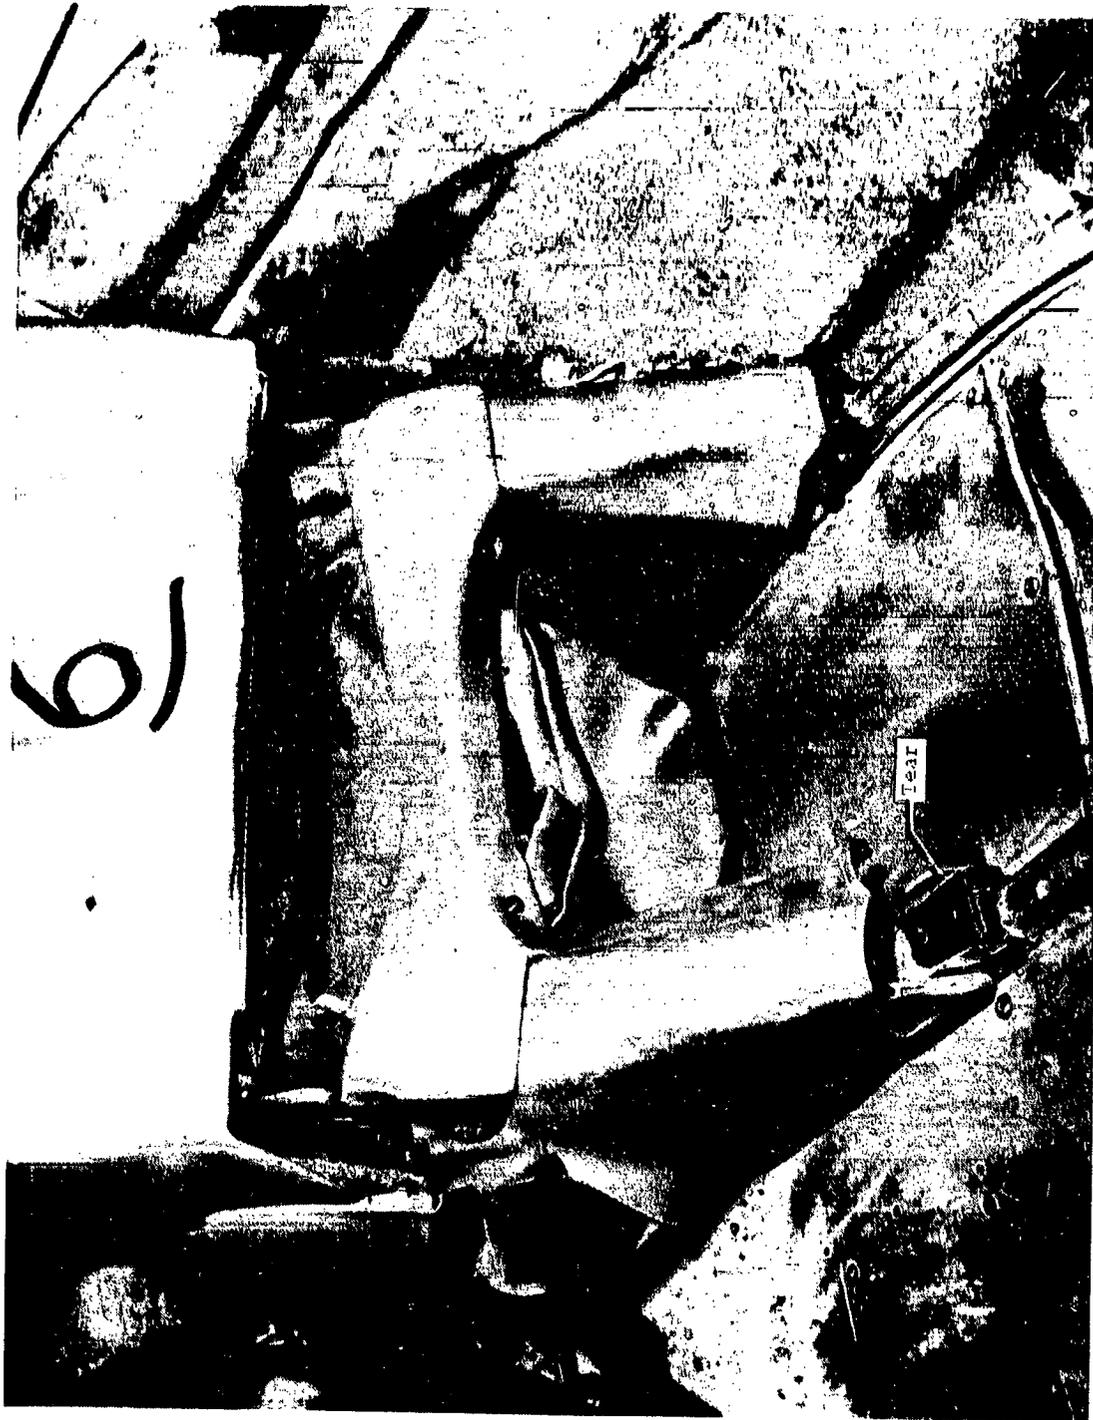
Figure 19.- Seat 6 of crashed Chieftain.

Only the left front attachment clamp of seat 6 (fig. 19) came free of the rail. The seat legs collapsed in front, and the seat generally deformed to the right and down. This seat is discussed more fully later in the report. The floor rail had very sharp bends at the front leg attachment points.

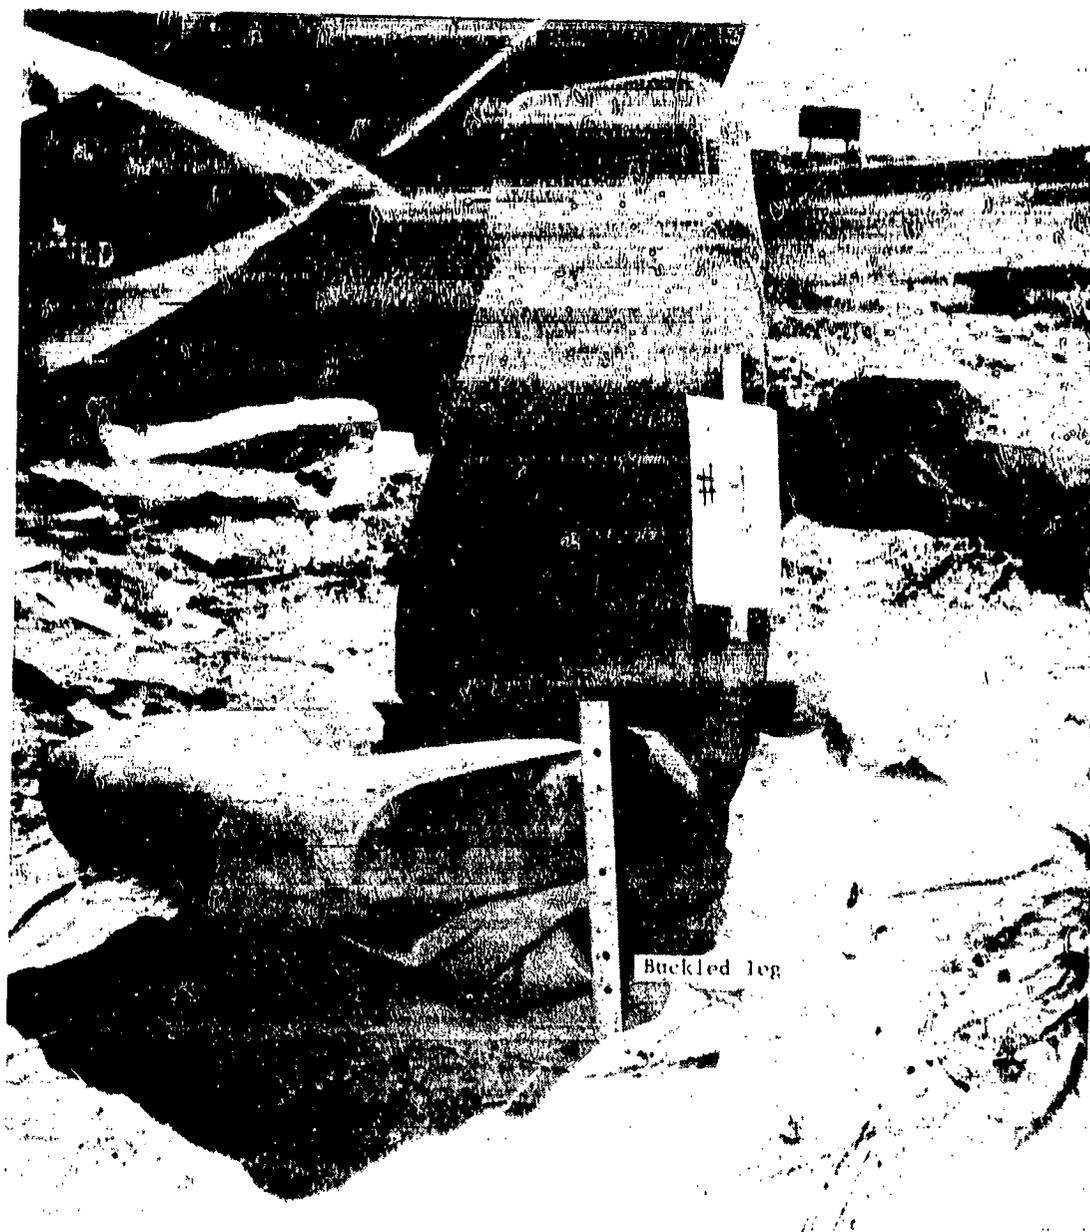
Figure 21.- Seat 9 of crashed Chieftain.

Passenger seat 9, shown removed from the airplane in figure 21, came loose during the crash. The front legs completely buckled under the seat and to the left. The seat frame was severely distorted with the rear member torn and bent downward and the right rear frame connection pulled apart. The floor tiedown plates exhibit damage from the pins which were pulled out. NASA has not had a similar seat on any of its tests.

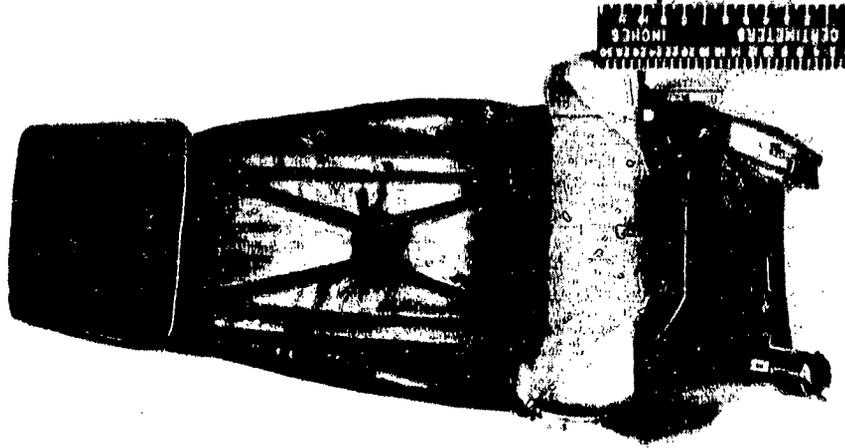
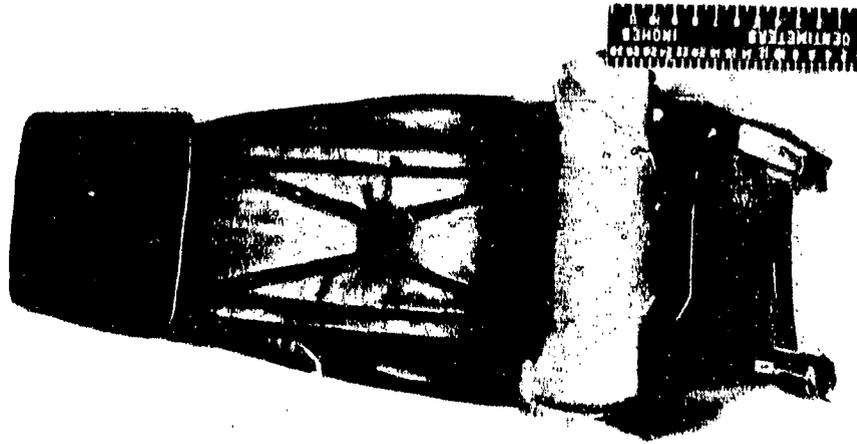
Figures 23(a) and 23(b) compare frontal views of seats 6 and 8 from the Chieftain with seat 3 from NASA test 15. The NASA test 15 specimen was a pressurized Navajo that impacted, rolled down to the left with the left wing nearly level, which caused the seat deformation to be opposite that of the Chieftain's. The weights of the occupants of seats 6 and 8 (71.7 and 75.3 kg (158 and 166 lb), respectively) were nearly the same as the weight of the dummy (74.8 kg (165 lb)) used in NASA test 15. Although the gross characteristics of the damage are the same, the damage is more severe in the accident case. The dummy in the NASA test went down through the seat. In addition, the rear member of the seat frame was bent downward and was almost completely separated on the right side. A similar failure occurred on the opposite side of Chieftain seat 8.

The comparison of seat damage indicates that the passengers of seats 6 and 8 of the Chieftain probably experienced pelvic accelerations in excess of those measured on the first passenger of NASA test 15.

4. The peak pelvic accelerations of passengers 6 and 8 were probably in excess of 60g normal, 40g longitudinal, and 10g transverse. This conclusion is based on a direct comparison between damage observed on seats 6 and 8 of the Chieftain and seat 3 of the airplane in NASA test 15.

(a) Seat 6 from Chieftain and seat 3 from pressurized Navajo.

(b) Seat 8 from Chieftain and seat 3 from NASA test 15 pressurized Navajo. I-79-273
